Technical Data Sheet

Bridge Identification:	1830110000000B01
Facility Carried:	M 37
Feature Intersected:	Pine River
Location:	South Branch Township
County:	Wexford
Region:	North
Year Built:	1948
Year Reconstructed:	1976, 1987
Bridge Type:	Two-Girder System
No. of Spans:	3
Deck Area:	13,895 S.F.
Paint System:	Type 4
Paint Area:	35,000 S.F.

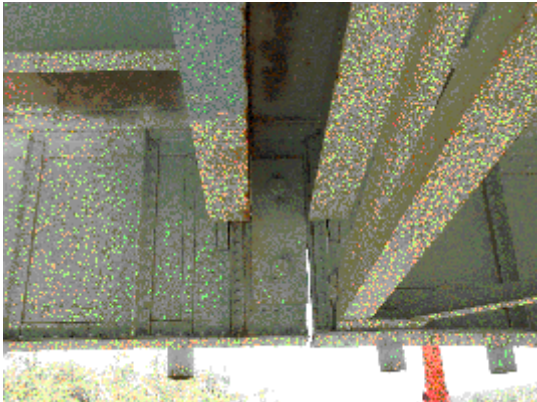
! Pin and hanger assemblies. (Photos 5 and 6)

Typical Pin and Hanger Assembly at Fixed Joint (5)

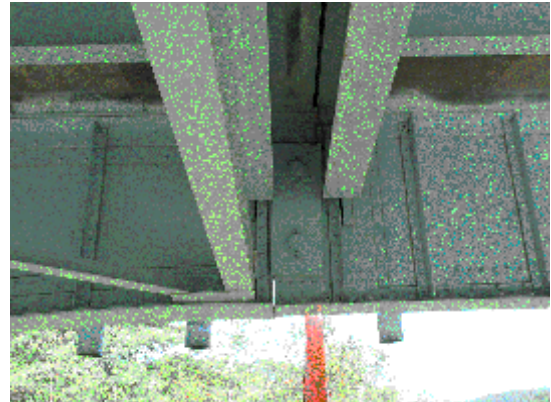
Typical Pin and Hanger Assembly at Expansion Joint (6)

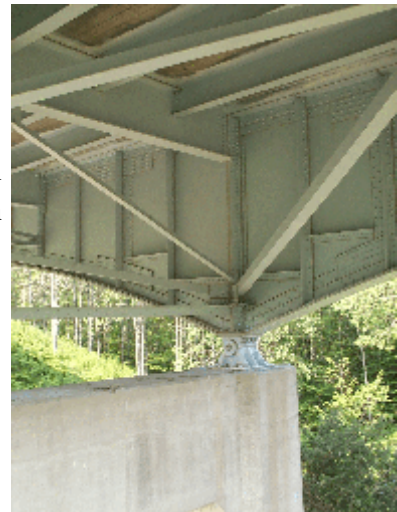
! Lateral bracing gusset plates at floorbeam connections. (Photo 7)

Typical Connection of Floorbeam to Girder at Pier (7)

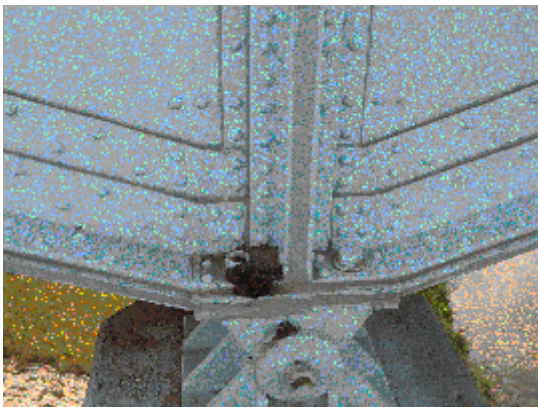
! Bearings and splice plates at piers. (Photos 8 and 9) These members have welds that should be carefully inspected.

Typical Welded Girder Splices at Pier (Exterior) (8)

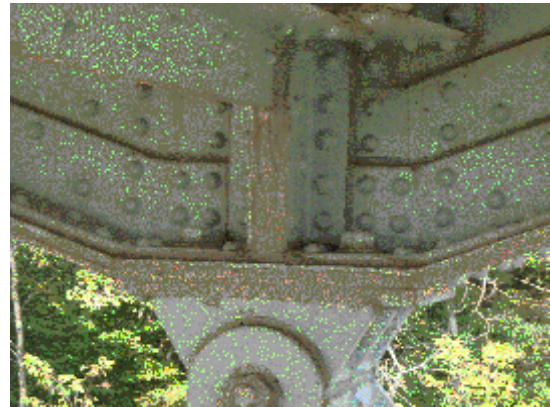
Typical Welded Girder Splices at Pier (Interior) (9)

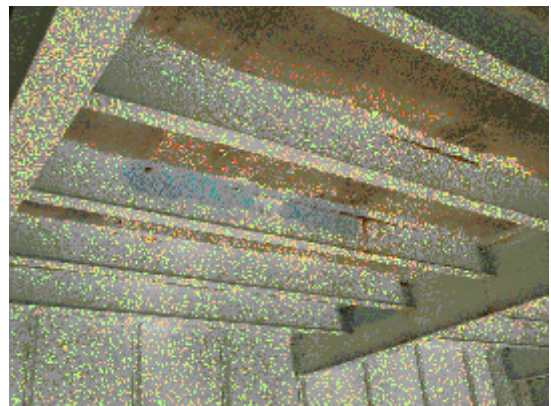
! Deck. (Photos 10 and 11) Deck overlays are susceptible to cracks and potholes. The cold joints in the deck over each floorbeam are susceptible to leaking, which allows corrosion to form on the top flanges of the floorbeams.

Corrosion at Underside of Deck in Suspended Span (11)

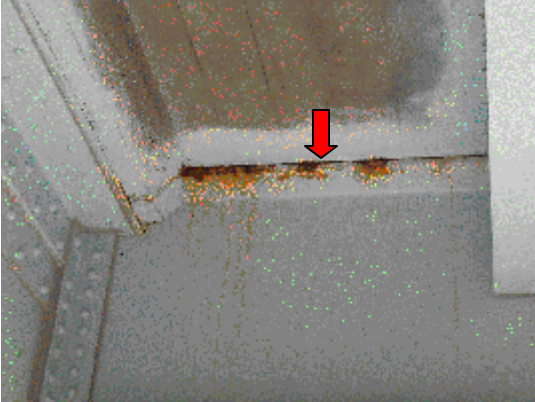
Corrosion Caused by Leaking Cold Joint in Deck (10)

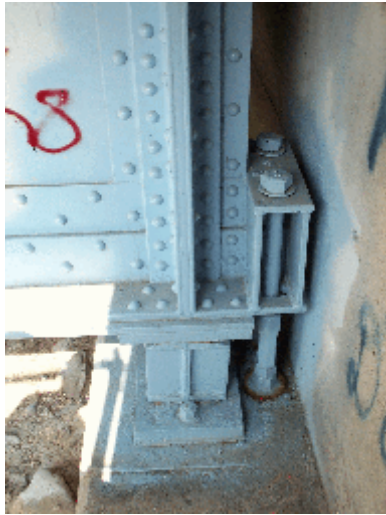
- ! **Bearings at abutments.** (Photos 12 and 13) These bearings have turnbuckle tie-downs, which should be tight-fitting to the bearings. When pack rust is removed from the bearings, the spans drop slightly and the tie-downs can loosen. These should be monitored for distress to the structure.

Typical Turnbuckle Tie-down at
Abutment (12)

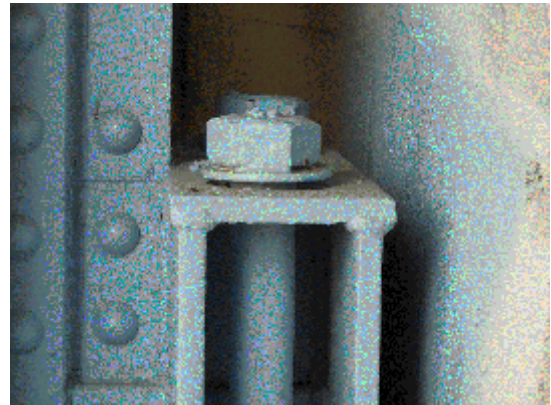
Loose Tie-down (13)

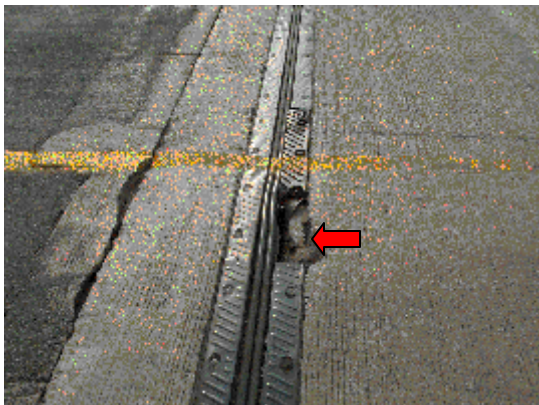
- ! **Joint at North Abutment.** (Photos 14 and 15) This joint is broken and the seal can tear, allowing it to leak excessively. Also, the joints are susceptible to collecting dirt and debris.

Broken/Torn Joint (14)

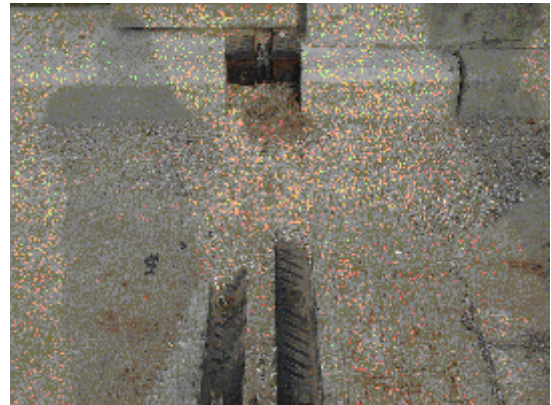
Joint Filled with Dirt/Debris (15)
